DEPARTMENT OF TRANSPORTATION

Quality Assurance and Source Inspection

Contract #: 04-0120F4Cty: SF/ALA Rte: 80 PM: 13.2/13.9File #: 1.28**WELDING INSPECTION REPORT****Resident Engineer:** Casey, William**Address:** 333 Burma Road**City:** Oakland, CA 94607**Report No:** WIR-026752**Date Inspected:** 23-Nov-2011**Project Name:** SAS Superstructure**OSM Arrival Time:** 700**Prime Contractor:** American Bridge/Fluor Enterprises, a JV**OSM Departure Time:** 1530**Contractor:** American Bridge/Fluor Enterprises, a JV**Location:** Job Site**CWI Name:** Pat Swain**CWI Present:** Yes No**Inspected CWI report:** Yes No N/A**Rod Oven in Use:** Yes No N/A**Electrode to specification:** Yes No N/A**Weld Procedures Followed:** Yes No N/A**Qualified Welders:** Yes No N/A**Verified Joint Fit-up:** Yes No N/A**Approved Drawings:** Yes No N/A**Approved WPS:** Yes No N/A**Delayed / Cancelled:** Yes No N/A**Bridge No:** 34-0006**Component:** OBG Sections**Summary of Items Observed:**

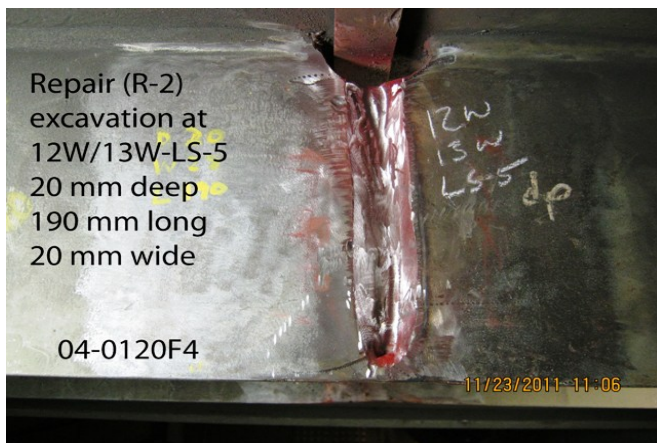
12W/13W-Longitudinal Stiffener (LS) – LS-5: This QA Inspector was informed the excavation of a second time repair (R-2) would be started this date. This QA Inspector observed ABF welding personnel Fred Kaddu (#2188) using the carbon arc process to excavate the defect found during Ultrasonic Testing (UT). This QA Inspector observed the excavation area after carbon arcing and grinding to remove any carbon deposits. This QA Inspector

observed QC Inspector Pat Swain perform a visual inspection and Magnetic Particle Testing (MT) on the excavation area and marked a short area that appeared to be slag trapped in the weld metal. This QA Inspector observed ABF welding personnel Fred Kaddu (#2188) continue with grinding the area. The grinding at this location was not completed this date therefore welding not performed this date. See photo below.

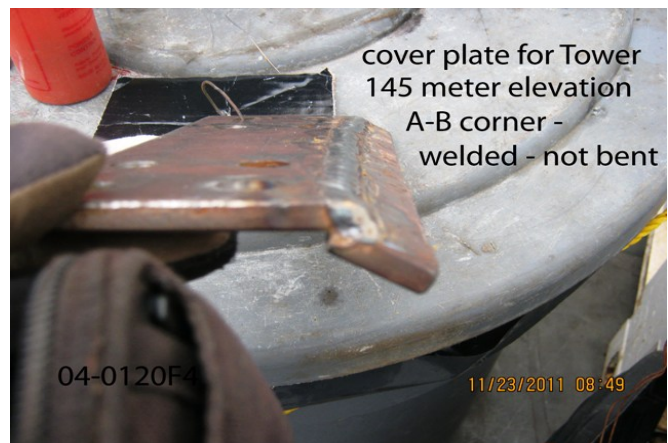
This QA Inspector was informed by QC Inspector Steve Jensen that he had obtained the approved drawings for the cover plates at the 145 meter elevation. This QA Inspector reviewed the drawings and observed they all appeared to have been stamped approved. This QA Inspector observed each of the four towers (North, South, East and West) were to have a cover plate at each of the 5 corners (A-B, B-C, C-D, D-E and E-A). QC Inspector Steve Jensen informed this QA Inspector that 18 of the 20 cover plates had been welded by ABF welding personnel Todd Jackson (#4639) and except for the 2 cover plates that were missing because the temporary steel bolted into position block access for their fabrication had been inspected and accepted. This QA Inspector randomly observed as QC Inspector Salvador Merino performed MT on what appeared to be a random section of the weld for a length of at least 10% of the weld length. The MT inspection observed by this QA Inspector appeared to comply with the contract requirements. This QA Inspector observed that 2 of the 18 cover plates appeared to have a Partial Joint Penetration (PJP) weld, this QA Inspector checked the drawing and did not observe a weld symbol had been specified. These 2 plates had a slight angle (approximately 30 degrees according to the drawing) and the drawings implied they were to have been bent rather than welded. This QA Inspector pointed this out to QC Inspector Steve Jensen and he stated he would have ABF look into the issue. See photo below of welded piece.
